Emerson's PeakVue™ Technology Detects Faulty Bearing at OMIFCO, Preventing Costly Breakdown

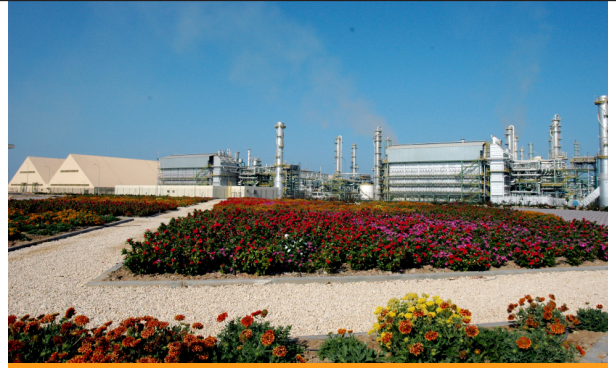
With this vibration technology, OMIFCO technicians quickly identified a potential problem in a turbine thrust bearing. The impacting faults were readily visible in PeakVue waveform long before any significant increase in overall vibration was noticed. As a result, OMIFCO engineers began to carefully monitor that machine. In February 2013, a sudden 50 percent increase in PeakVue spectrum and waveform was observed, followed a few days later by another large increase. At this time, a slight increase in turbine horizontal vibration velocity was evident for the first time.

At this point, the machine was taken out of service to check the thrust bearing, which was found to be severely damaged with large pitting in the inner race and additional small pitting in the balls. After the thrust bearing was replaced and the machine put back into service, all of the vibration readings returned to normal levels.
