# PREEM SOLVES A PERSISTENT REFINERY CORROSION PROBLEM USING ONLINE CORROSION MONITORING

This case study focuses on a specific instance of severe corrosion identified on the top of a main crude distillation column in Preem’s Lysekil refinery in Sweden. The problem was located near a complex arrangement of pressure relief valves, and attempts were made to alleviate the corrosion through redesign of the piping in that area and the installation of a new injection quill. However, despite initial success, corrosion began to reoccur.

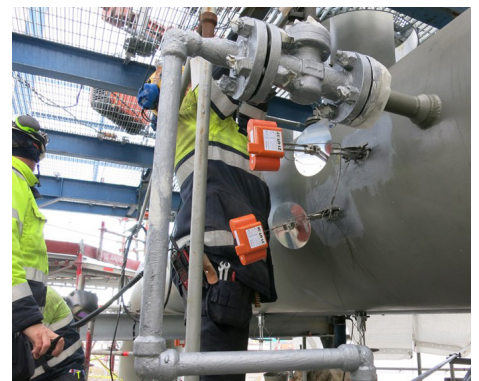
**Image 1.** Several Rosemount Wireless Permasense sensors were deployed next to the

The corrosion engineer installed a Rosemount Wireless Permasense corrosion monitoring system from Emerson to continuously monitor the corrosion rate and identify the root cause of the corrosion.

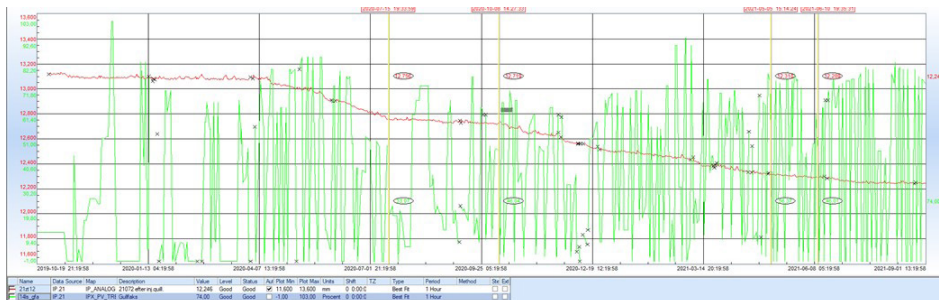
**Image 2.** Periods of high corrosion (red trend line) could be clearly correlated with periods of crude slate blending (green trend line).

The corrosion data was correlated with process data using AspenTech IP.21 software (see image 2). The corrosion was caused by a specific crude slate which was high in salts, causing corrosion further down the process. However, when this new crude was blended back out, the corrosion did not stop occurring. The team performed an inspection of the injection location where the issues initially occurred and found out that the injection quill was broken once again, likely causing inhibitor to spread along the pipe wall where the non-intrusive sensors were located.

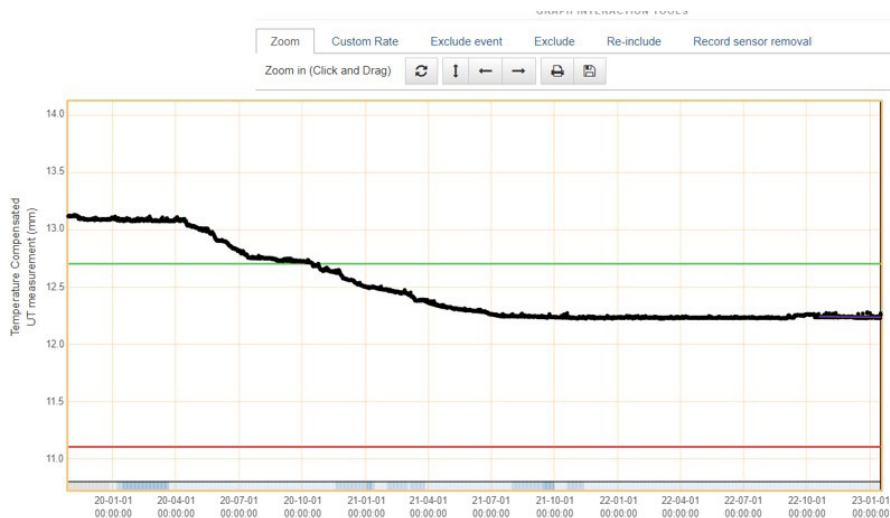
**Image 3.** Since replacing the quill in September 2021 the corrosion was virtually eliminated. Continuous monitoring ensures any recurrence would be picked up quickly.

In July 2021 the injection of neutralising amine was stopped and the corrosion rate was significantly reduced (see image 3). In September 2021 another new injection quill was installed. The refinery was able to prevent further corrosion and ensure the longevity and integrity of the pipes by using advanced monitoring and diagnostic tools such as Permasense and AspenTech IP.21 software. This also helped to perform effective predictive maintenance and avoid unexpected shutdowns. Although not certain, it is likely that a combination of the high salt crude blend as well as the broken injection quill were causing the corrosion.
