## PULP AND PAPER SUPPLIER REDUCES MAINTENANCE COST WITH GROUND AND WIRING FAULT DIAGNOSTIC

Aluminum Sulfate Flow

Leading global supplier of pulp and paper products

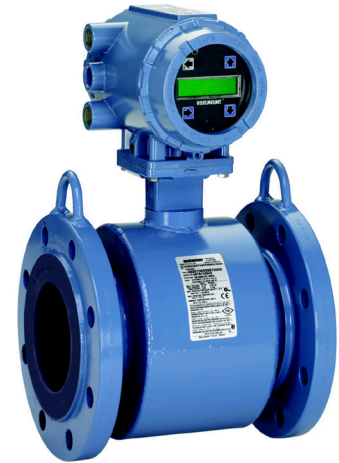
*Rosemount 8700 Magnetic Flow Meter*

To investigate the problem, an instrumentation technician was assigned to troubleshoot the meter. Since the installed meter was a Rosemount™ 8700 Magnetic Flow Meter with the ground/wiring diagnostic option enabled, the LCD immediately informed the technician there was a “Ground/Wire Fault.” With this information, the technician reviewed the wiring and found a wire’s shielding incorrectly connected to an active coil. The wires were then connected to the correct terminals, and power was re-applied to the flow meter. A correct and stable flow measurement was restored.
